COMPOSITE DECKING BOARD

DOCUMENT REFERENCE: DR-5114
PROJECT FILE REFERENCE: S10147

Prepared for: Cladco Profiles Limited
North Industrial Estate, North Road, Okehampton, Devon, EX20 1BQ

STS (U.K) Group were commissioned by Cladco Profiles Limited to undertake a series of load tests and nail penetration tests on two types of wood-plastic decking. All testing was carried out by STS (U.K). The purpose of the testing was to attain results and findings that could be analysed to see the difference between the solid decking and the hollow decking. Each component was inspected for damage before and after testing was carried out.

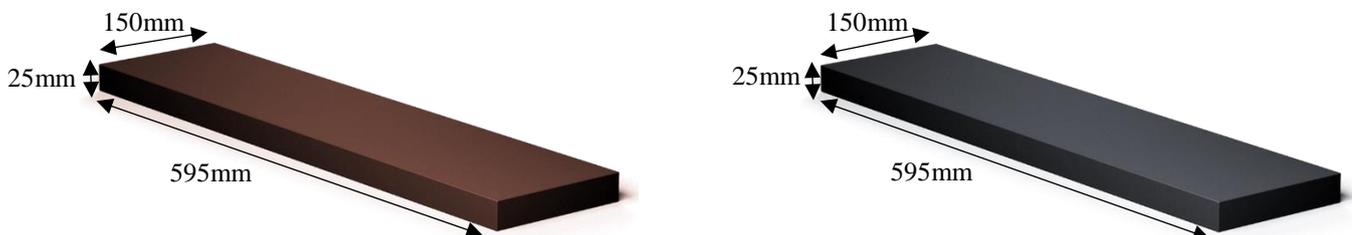
Pictures 1 & 2 – (Left) Solid decking. (Right) Hollow decking with 4 hollow centers (27mm x 13mm).

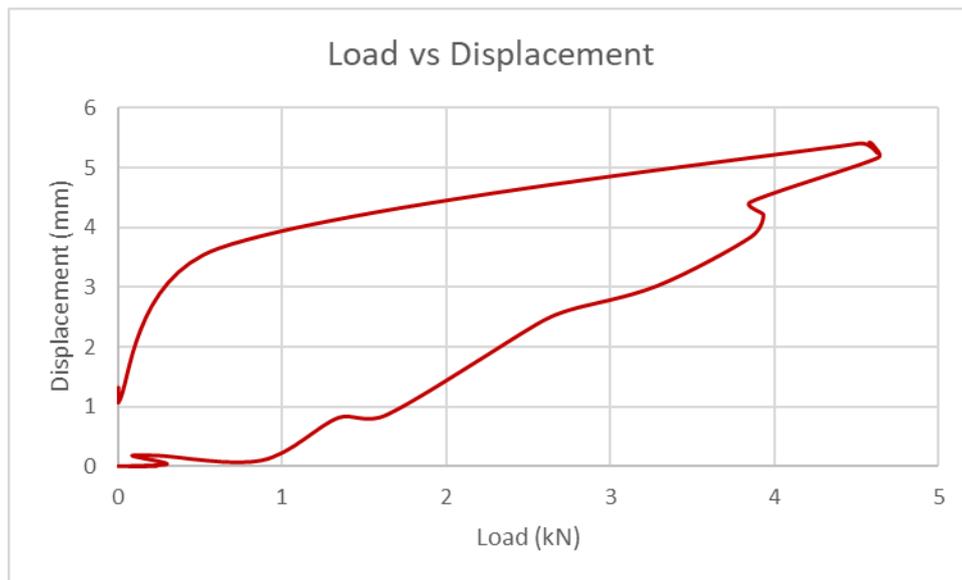
TEST DETAILS: Test 1 – Hollow Decking – 595mm x 150mm x 25mm. Hollow centres – 27mm x 13mm

Load (kN)	Maximum Displacement (mm)	Permanent Displacement (mm)	Pass/Fail
4.5	5.41	1.09	Pass

The Hollow Decking when assembled and tested in the manor indicated within this certificate conforms to BS 6399-Part 1-1996. The system achieved a load of 4.5kN with a maximum recorded displacement of 5.41mm.

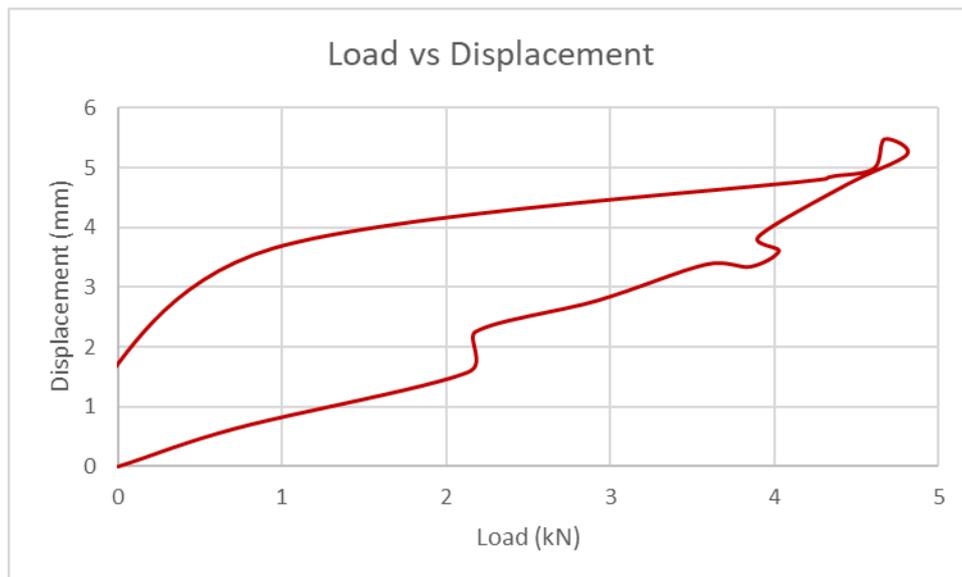
TEST DETAILS: Test 2 – Hollow Decking – 595mm x 150mm x 25mm. Hollow Centres – 27mm x 13mm

Load (kN)	Maximum Displacement (mm)	Permanent Displacement (mm)	Pass/Fail
4.5	5.47	0.56	Pass

The Hollow Decking when assembled and tested in the manor indicated within this certificate conforms to BS 6399-Part 1-1996. The system achieved a load of 4.5kN with a maximum recorded displacement of 5.47mm.

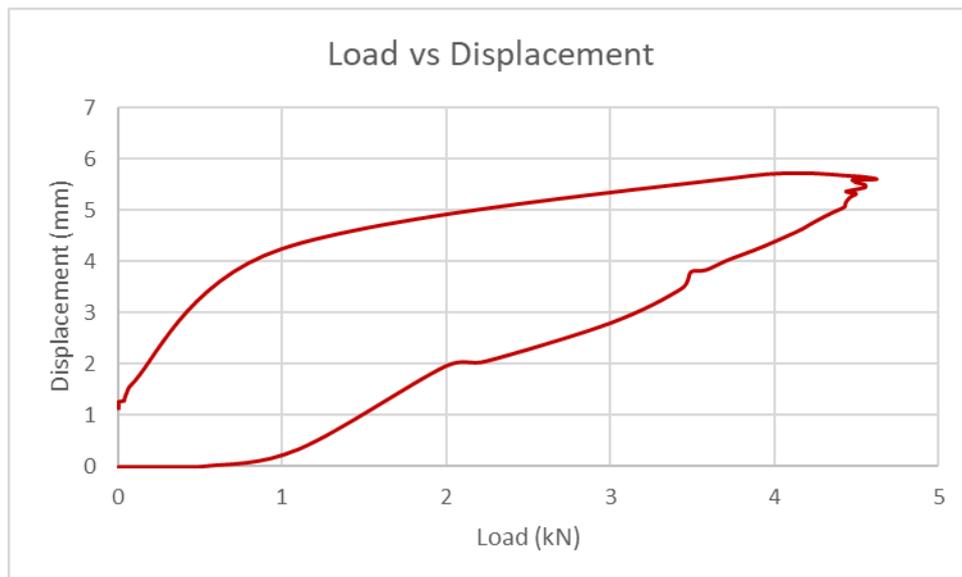
TEST DETAILS: Test 3 – Hollow Decking – 595mm x 150mm x 25mm. Hollow Centres – 27mm x 13mm

Load (kN)	Maximum Displacement (mm)	Permanent Displacement (mm)	Pass/Fail
4.5	5.68	1.14	Pass

The Hollow Decking when assembled and tested in the manor indicated within this certificate conforms to BS 6399-Part 1-1996. The system achieved a load of 4.5kN with a maximum recorded displacement of 5.68mm.

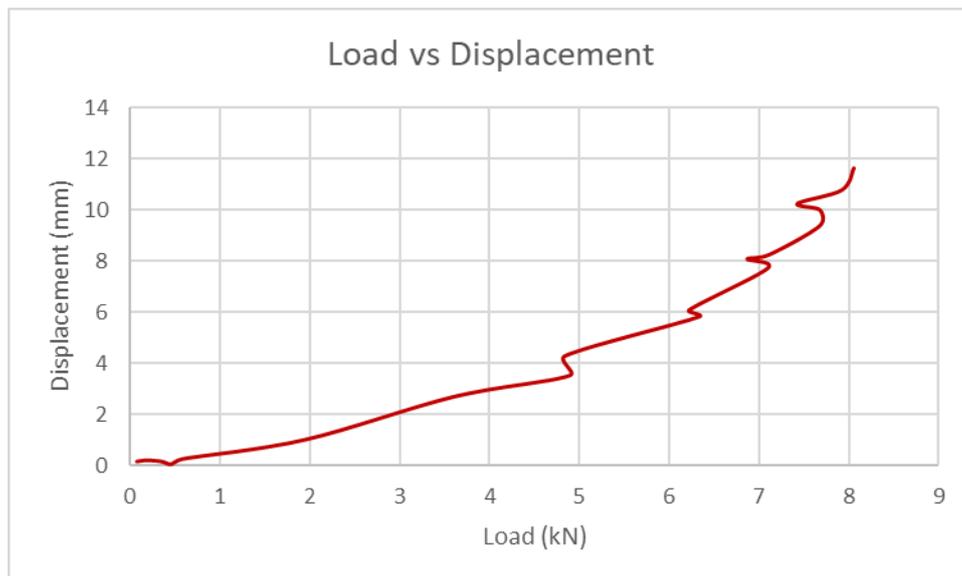
TEST DETAILS: Test 4 – Hollow Decking – 595mm x 150mm x 25mm. Hollow Centres – 27mm x 13mm

Load Achieved (kN)	Maximum Displacement (mm)
8.06	11.62

The Hollow Decking when assembled and tested in the manor indicated within this certificate achieved a load of 8.06kN with a maximum recorded displacement of 11.62mm before the panel failed.

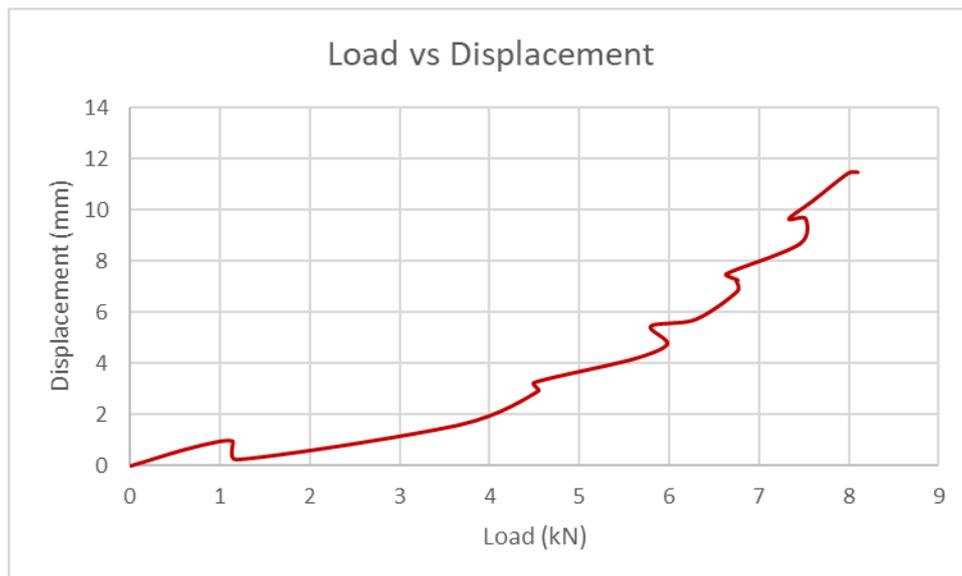
TEST DETAILS: Test 5 – Hollow Decking – 595mm x 150mm x 25mm. Hollow Centres – 27mm x 13mm

Load Achieved (kN)	Maximum Displacement (mm)
8.09	11.46

The Hollow Decking when assembled and tested in the manor indicated within this certificate achieved a load of 8.09kN with a maximum recorded displacement of 11.46mm before the panel failed.

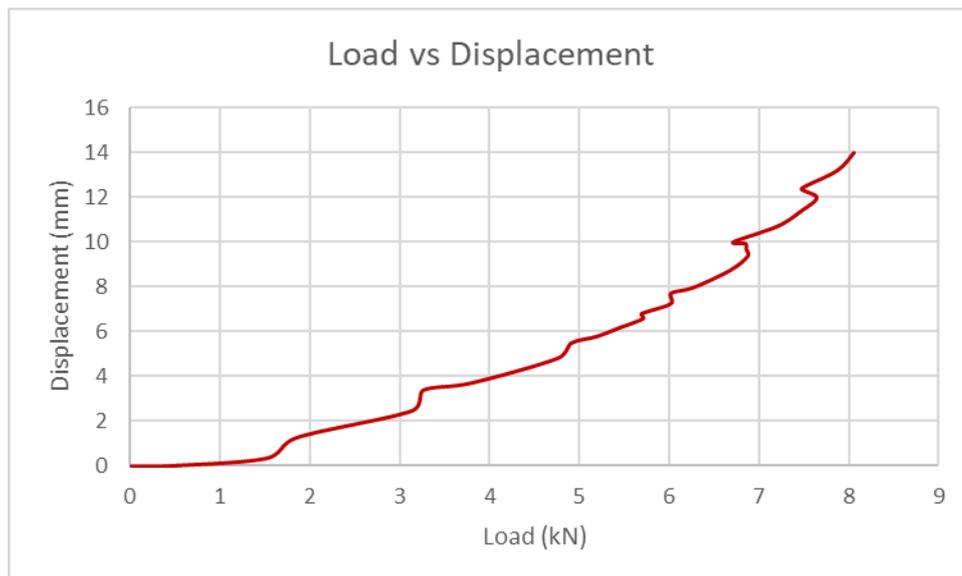
TEST DETAILS: Test 6 – Hollow Decking – 595mm x 150mm x 25mm. Hollow Centres – 27mm x 13mm

Load Achieved (kN)	Maximum Displacement (mm)
8.05	13.99

The Hollow Decking when assembled and tested in the manor indicated within this certificate achieved a load of 8.05kN with a maximum recorded displacement of 13.99mm before the panel failed.

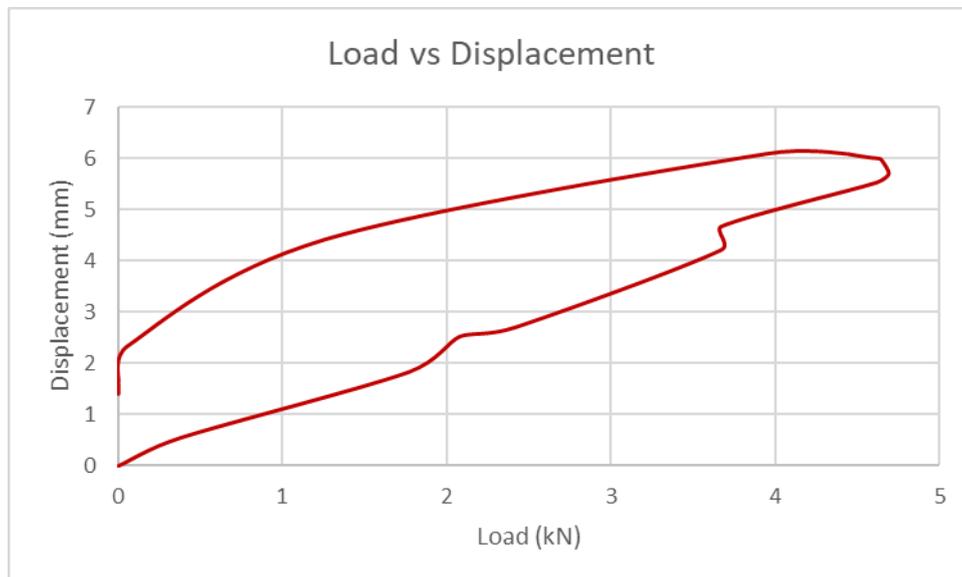
TEST DETAILS: Test 7 – Solid Decking – 595mm x 150mm x 25mm

Load (kN)	Maximum Displacement (mm)	Permanent Displacement (mm)	Pass/Fail
4.5	6.09	1.40	Pass

The Solid Decking when assembled and tested in the manor indicated within this certificate conforms to BS 6399-Part 1-1996. The system achieved a load of 4.5kN with a maximum recorded displacement of 6.09mm.

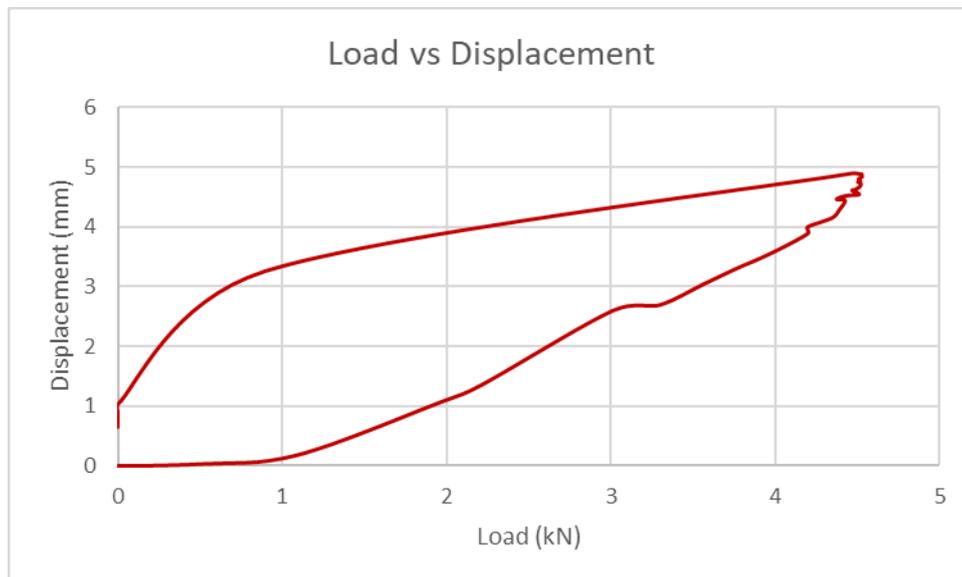
TEST DETAILS: Test 8 – Solid Decking – 595mm x 150mm x 25mm

Load (kN)	Maximum Displacement (mm)	Permanent Displacement (mm)	Pass/Fail
4.5	4.87	0.64	Pass

The Solid Decking when assembled and tested in the manor indicated within this certificate conforms to BS 6399-Part 1-1996. The system achieved a load of 4.5kN with a maximum recorded displacement of 4.87mm.

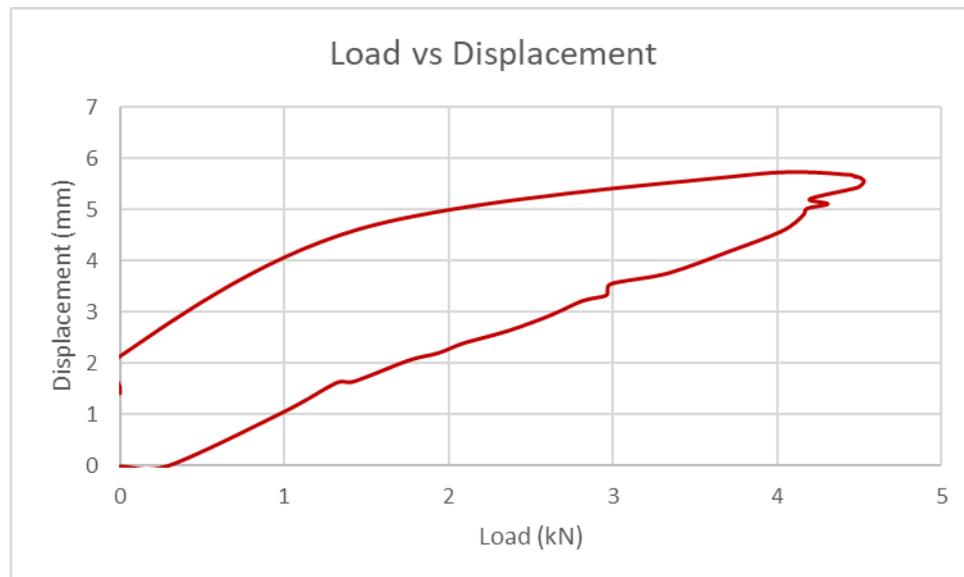
TEST DETAILS: Test 9 – Solid Decking – 595mm x 150mm x 25mm

Load (kN)	Maximum Displacement (mm)	Permanent Displacement (mm)	Pass/Fail
4.5	5.69	1.42	Pass

The Solid Decking when assembled and tested in the manor indicated within this certificate conforms to BS 6399-Part 1-1996. The system achieved a load of 4.5kN with a maximum recorded displacement of 5.69mm.

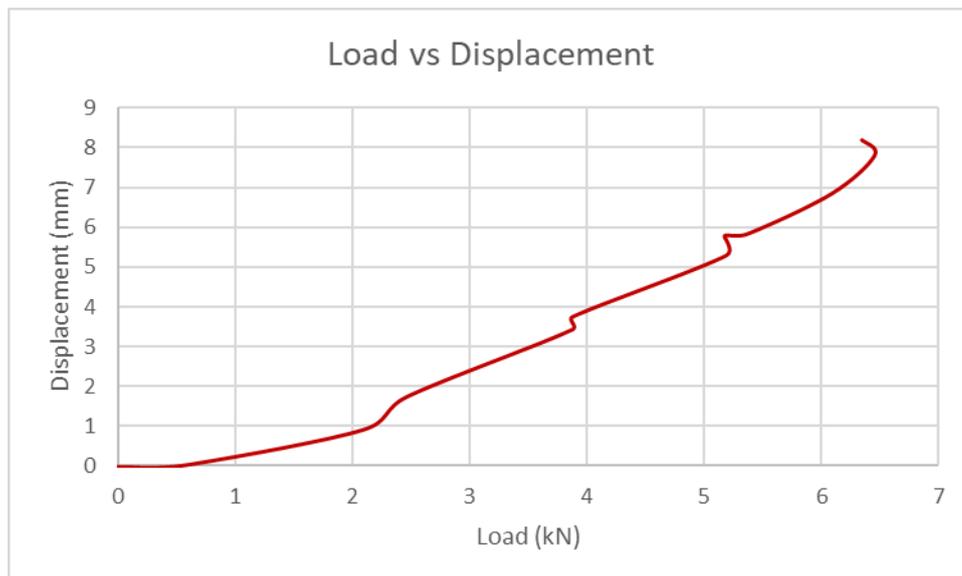
TEST DETAILS: Test 10 – Solid Decking – 595mm x 150mm x 25mm

Load Achieved (kN)	Maximum Displacement (mm)
6.34	8.20

The Solid Decking when assembled and tested in the manor indicated within this certificate achieved a load of 6.34kN with a maximum recorded displacement of 8.20mm before the panel failed.

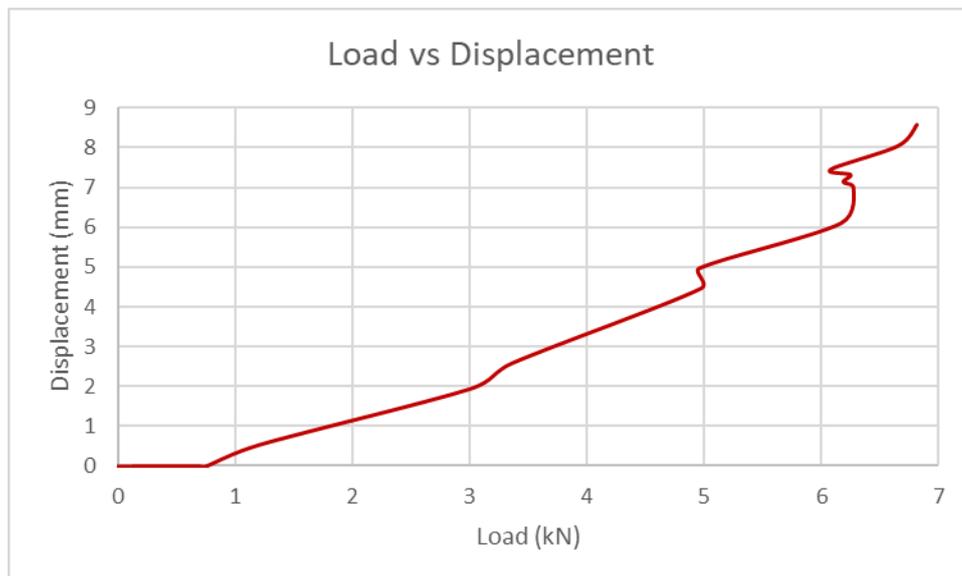
TEST DETAILS: Test 11 – Solid Decking – 595mm x 150mm x 25mm

Load Achieved (kN)	Maximum Displacement (mm)
6.81	8.57

The Solid Decking when assembled and tested in the manor indicated within this certificate achieved a load of 6.81kN with a maximum recorded displacement of 8.57mm before the panel failed.

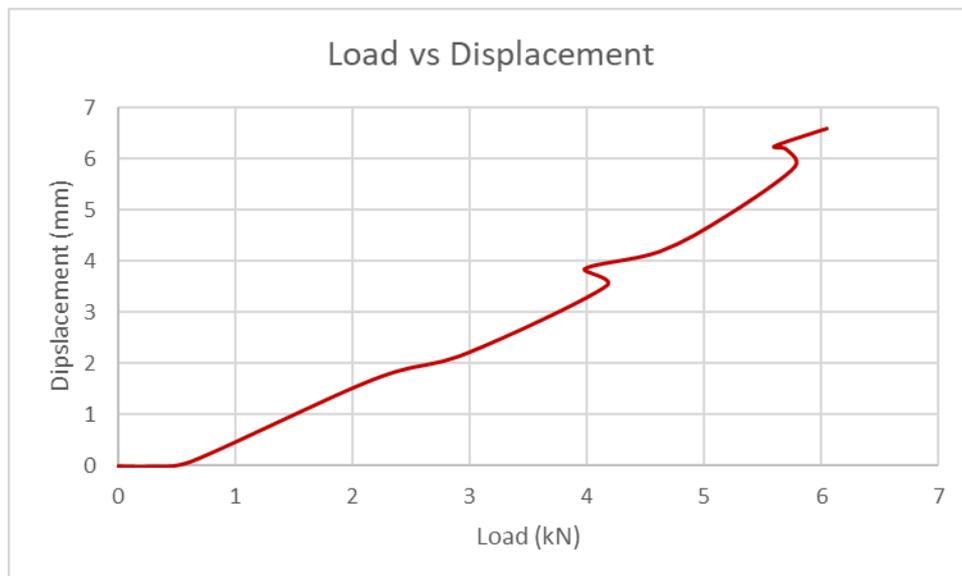
TEST DETAILS: Test 12 – Solid Decking – 595mm x 150mm x 25mm

Load Achieved (kN)	Maximum Displacement (mm)
6.04	6.59

The Solid Decking when assembled and tested in the manor indicated within this certificate achieved a load of 6.04kN with a maximum recorded displacement of 6.59mm before the panel failed.

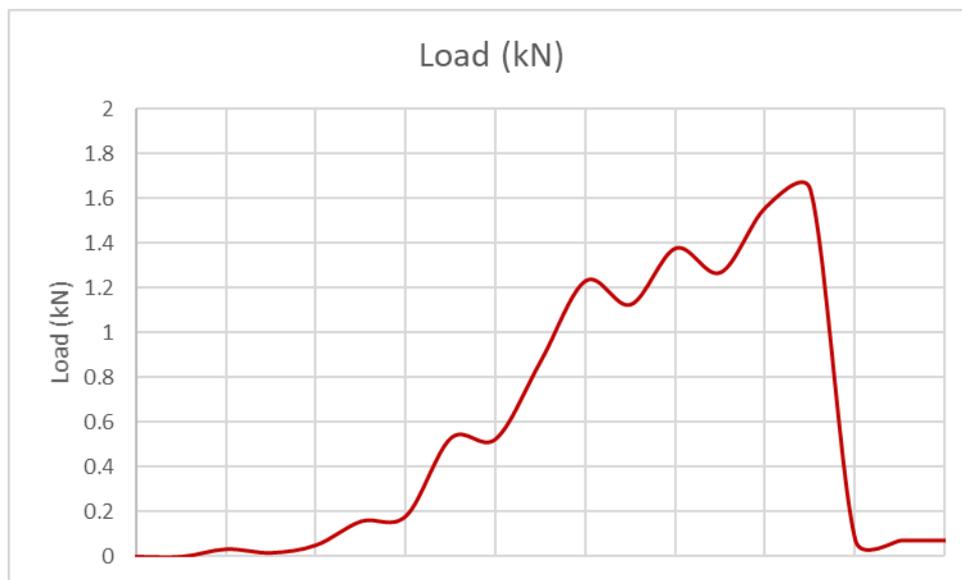
Load Required (kN)	Depth of Nail Penetration (mm)
1.63	25

The Solid Decking when assembled and tested in the manor indicated within this certificate required a load of 1.63Kn to penetrate the solid decking with a 3.3mm galvanised nail.

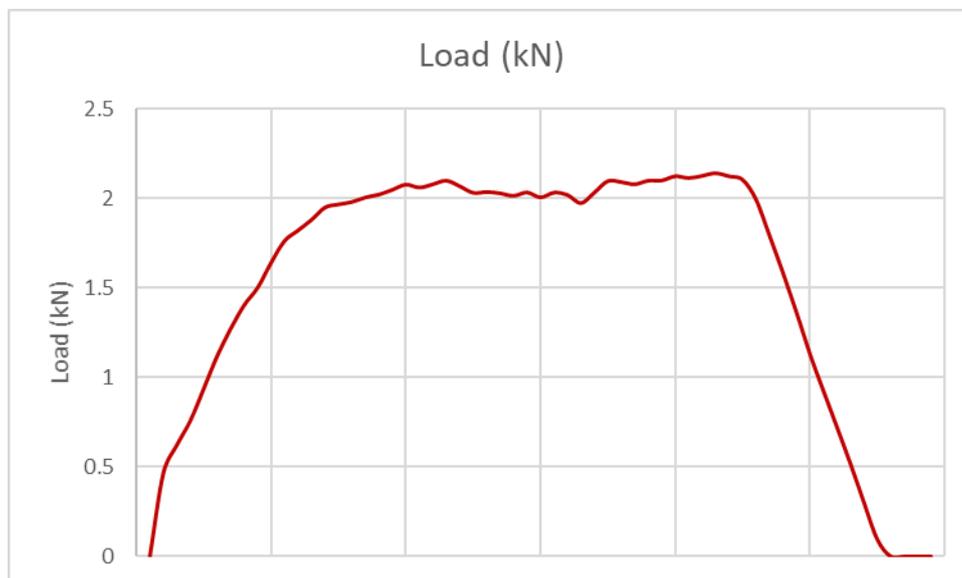
Load Required (kN)	Depth of Nail Penetration (mm)
2.06	25

The Solid Decking when assembled and tested in the manor indicated within this certificate required a load of 2.06Kn to penetrate the solid decking with a 3.3mm galvanised nail.

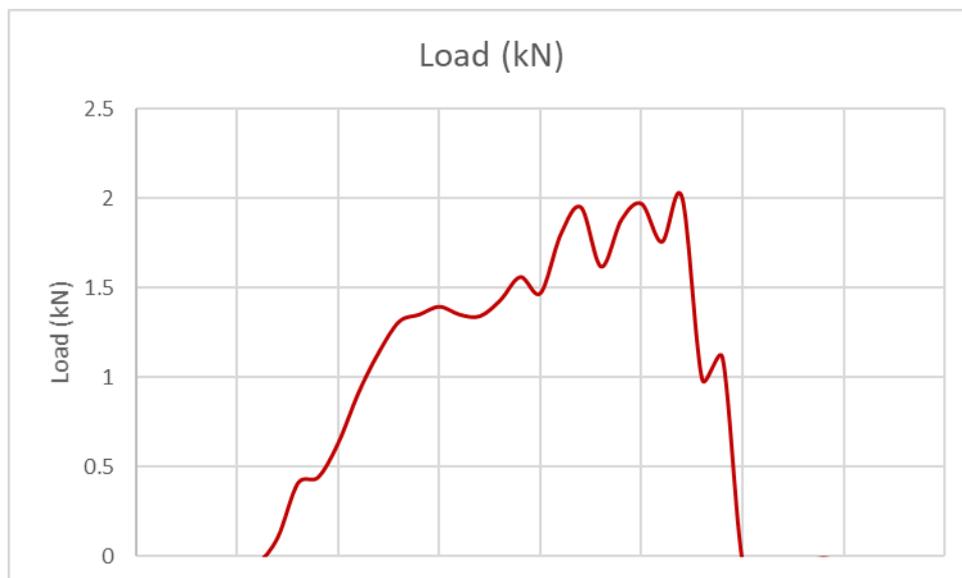
Load Required (kN)	Depth of Nail Penetration (mm)
1.95	25

The Solid Decking when assembled and tested in the manor indicated within this certificate required a load of 1.95Kn to penetrate the solid decking with a 3.3mm galvanised nail.

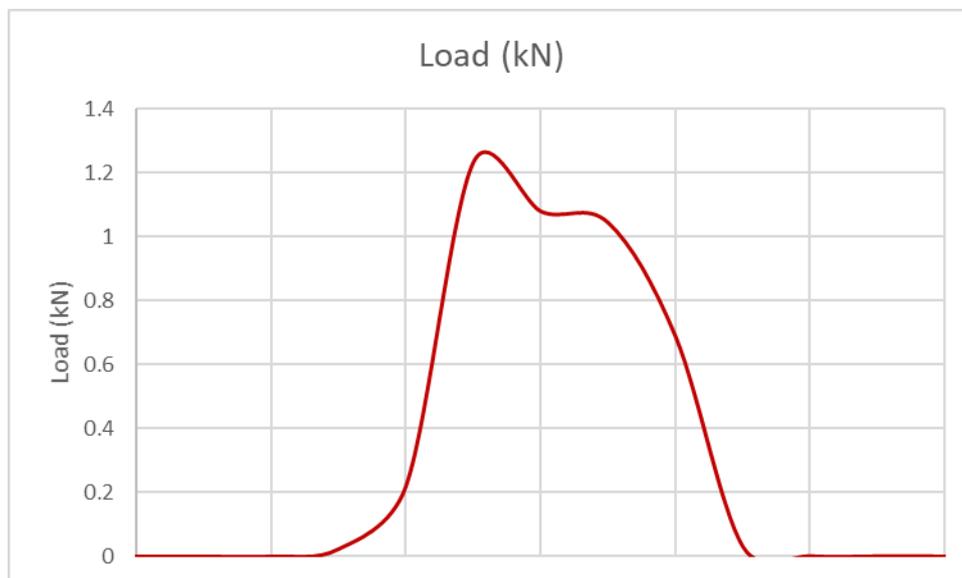
Load Required (kN)	Depth of Nail Penetration (mm)
1.23	25

The Chambered Decking when assembled and tested in the manor indicated within this certificate required a load of 1.23Kn to penetrate the solid decking with a 3.3mm galvanised nail.

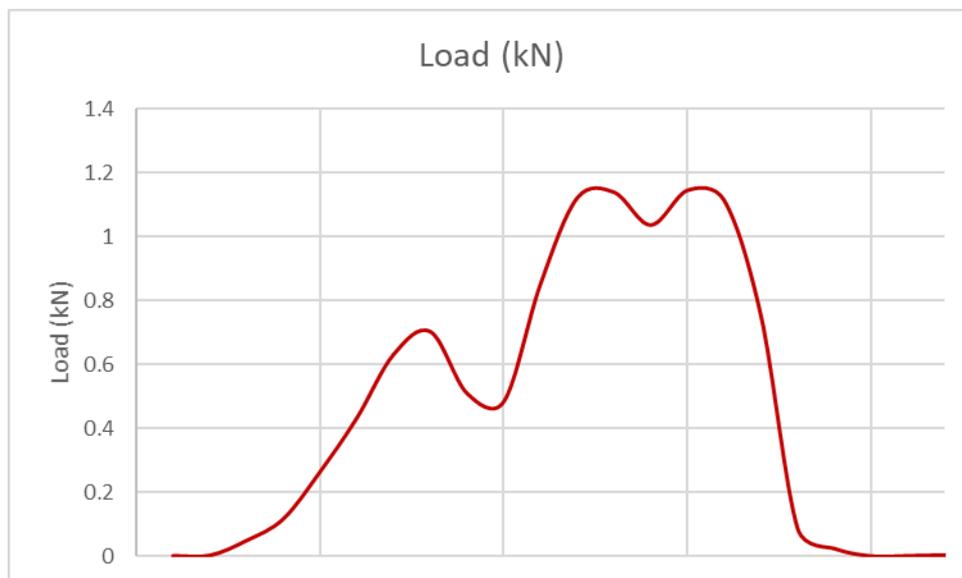
Load Required (kN)	Depth of Nail Penetration (mm)
1.13	25

The Hollow Decking when assembled and tested in the manor indicated within this certificate required a load of 1.13Kn to penetrate the solid decking with a 3.3mm galvanised nail.

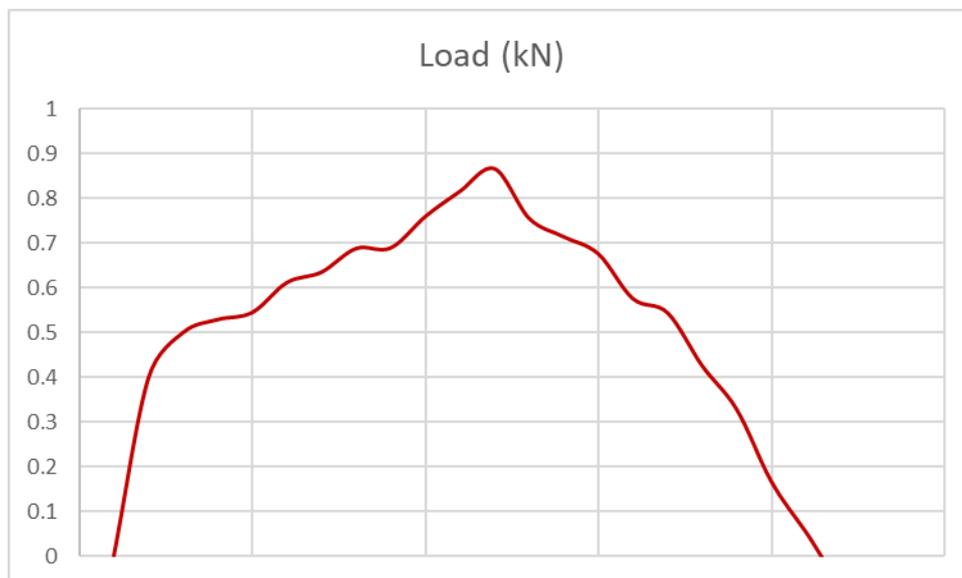
Load Required (kN)	Depth of Nail Penetration (mm)
0.87	25

The Hollow Decking when assembled and tested in the manor indicated within this certificate required a load of 1.13Kn to penetrate the solid decking with a 3.3mm galvanised nail.

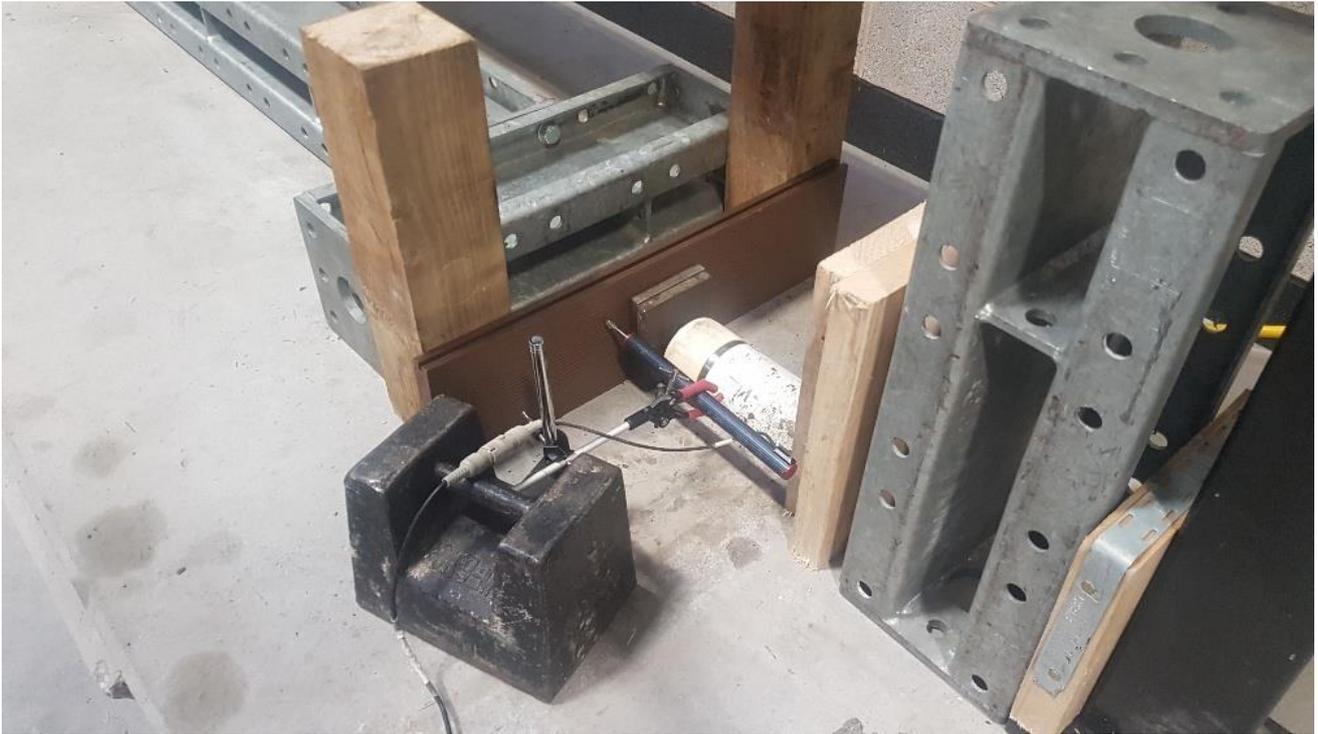
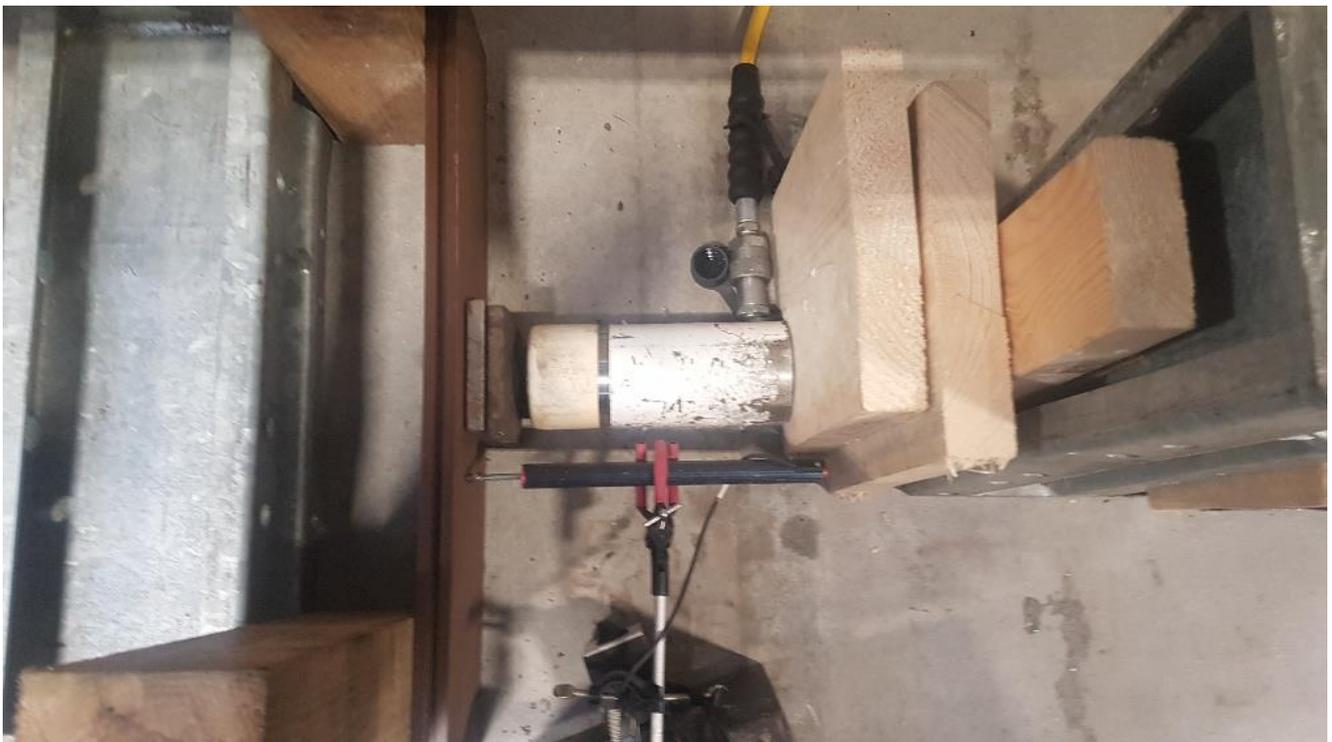
Pictures 3 & 4 – Test Setup to test the Solid and Hollow decking up to a concentrated load of 4.5kN and the testing to failure for both the Hollow and Solid Decking.

During the tests, the load was applied using a hydraulic cylinder attached to a pressure sensor. This allowed us to monitor the load during each test. The displacement was monitored continuously throughout each test. This was measured using a 100mm Spring Loaded Potentiometer situated outside the zone of influence on a freestanding tripod and recorded using a bespoke logging system. Displacements will be plotted to a screen such that any non-elastic displacement will be instantly identified. After applying the load the test will be complete and the load removed.

The first set of testing carried out was on the 595mm x 150mm x 25mm Specimens of the Hollow Decking and the 595mm x 150mm x 25mm Solid Decking. As per BS 6399-Part 1-1996. The required concentrated loading for an area which people may congregate is 4.5kN. Three tests were carried out on three different samples of the hollow decking (Results for these tests can be found in Section 3 and Appendix A of this report). Conducting three of these tests allowed us to gain an average in results. The load was applied via a hydraulic cylinder situated directly central and above the wood-plastic decking. The load was applied by way of a hand pump in a steady manner and displacement was recorded prior to load, during the test and after all load had been removed.

The next set of testing carried out was to failure. Three samples of both the Hollow and Solid decking were tested to failure in order to gain an average in the maximum loading the wood-plastic decking could take before failing (Results for these tests can be found in Section 3 and Appendix A of this report). The load was applied continuously via a hand pump connected to a hydraulic cylinder. The load was steadily increased until the wood-plastic decking sample failed and split into two pieces. This allowed us to find the ultimate strength of the decking.

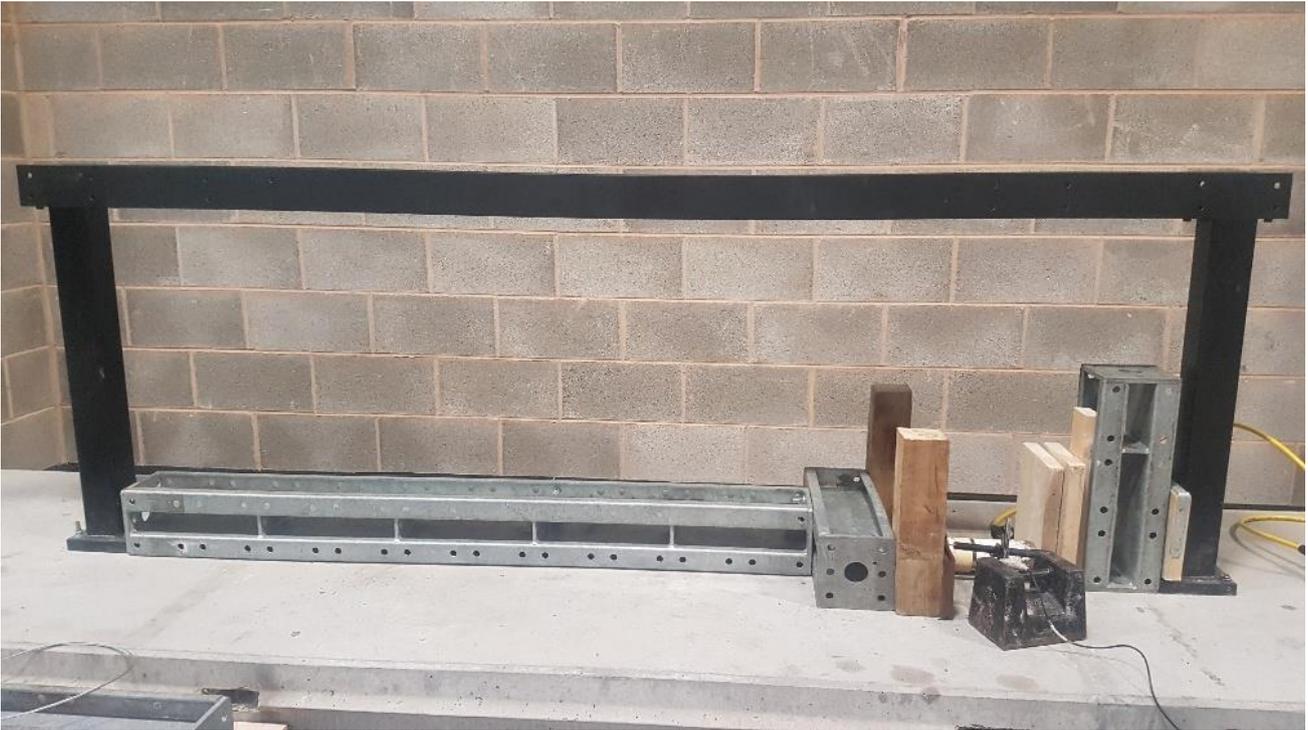
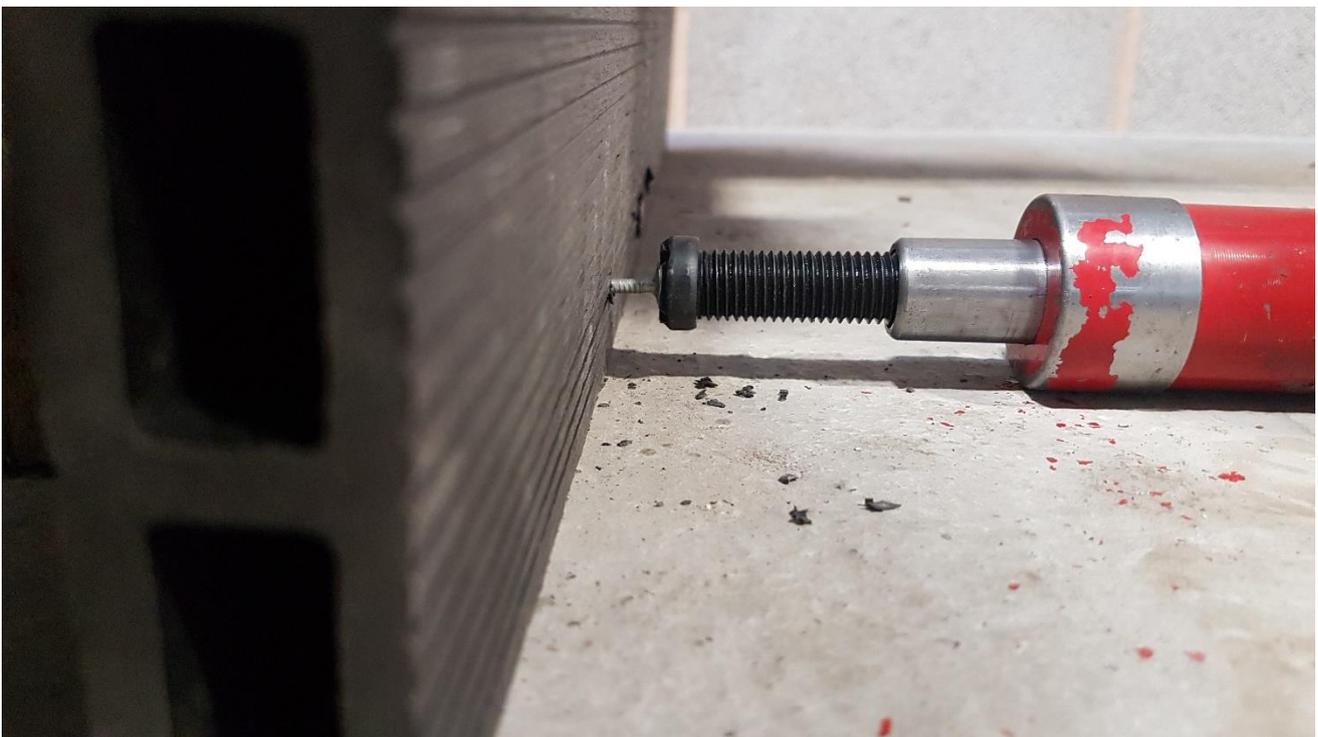
Pictures 5 & 6 – Test Setup to test the Solid and Hollow decking up to a concentrated load of 4.5kN and the Nail Penetration Testing.

The final set of testing carried out was a nail penetration test. A total of 3 tests were carried out on both the Hollow and Solid Decking. This test was conducted to determine the actual force required to penetrate the decking with a 3.3mm nail. The nail was steadily pushed into the wood-plastic decking via a hydraulic cylinder connected to a hand pump.

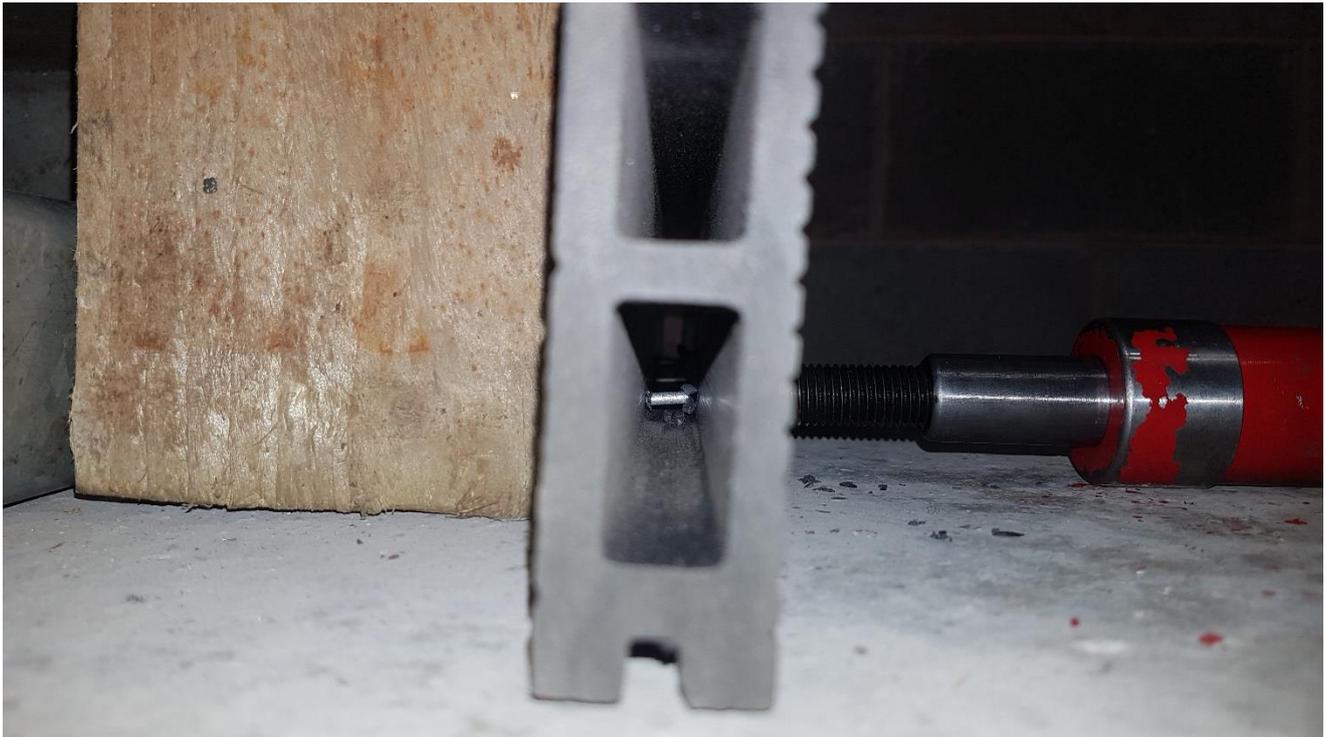
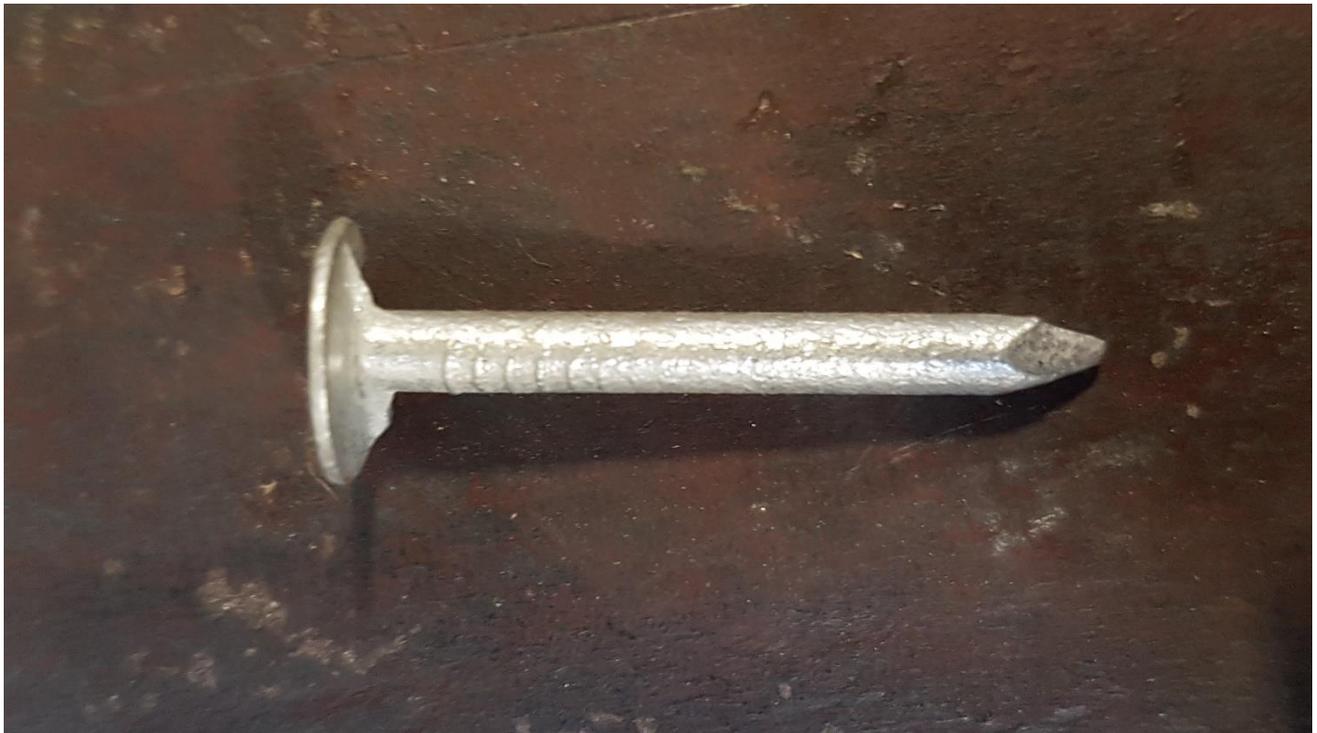
Pictures 7 & 8 – Picture of the nail fully penetrating the Hollow Decking and a picture of the type of nails used for the penetration testing.

Table 3 shows us the maximum recorded load required to penetrate the wood-plastic decking with a 3.3mm Galvanized Round Head nail. Three nail penetration tests were carried out on the Hollow decking and three tests carried out on the Solid decking.

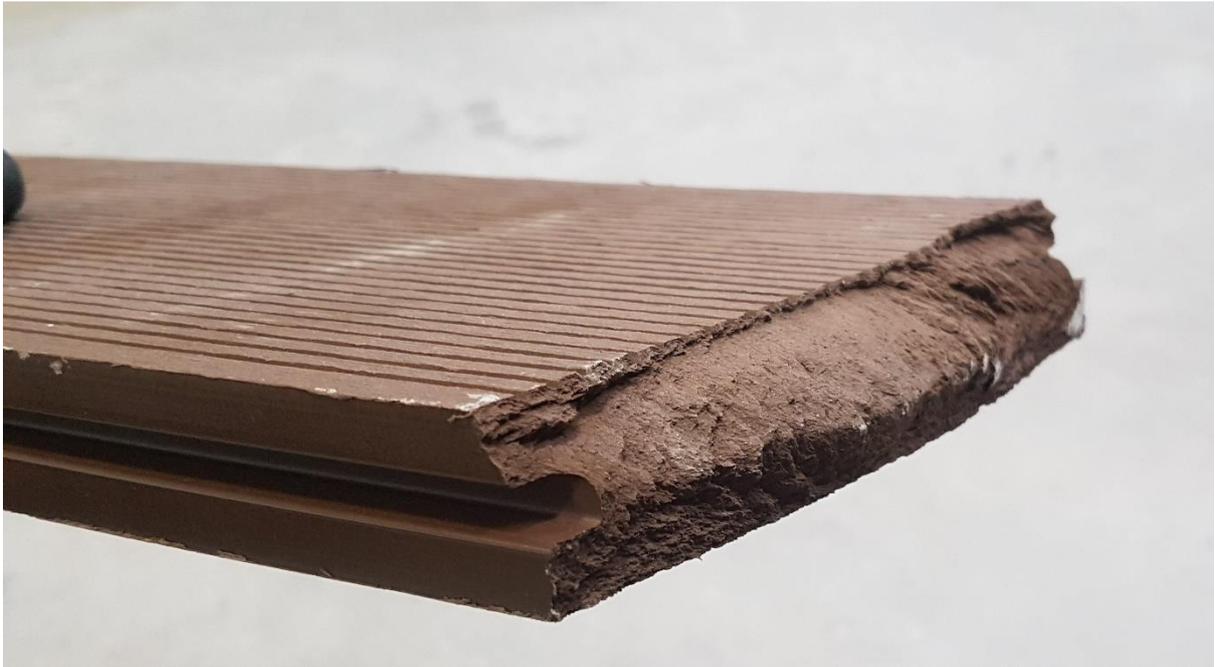
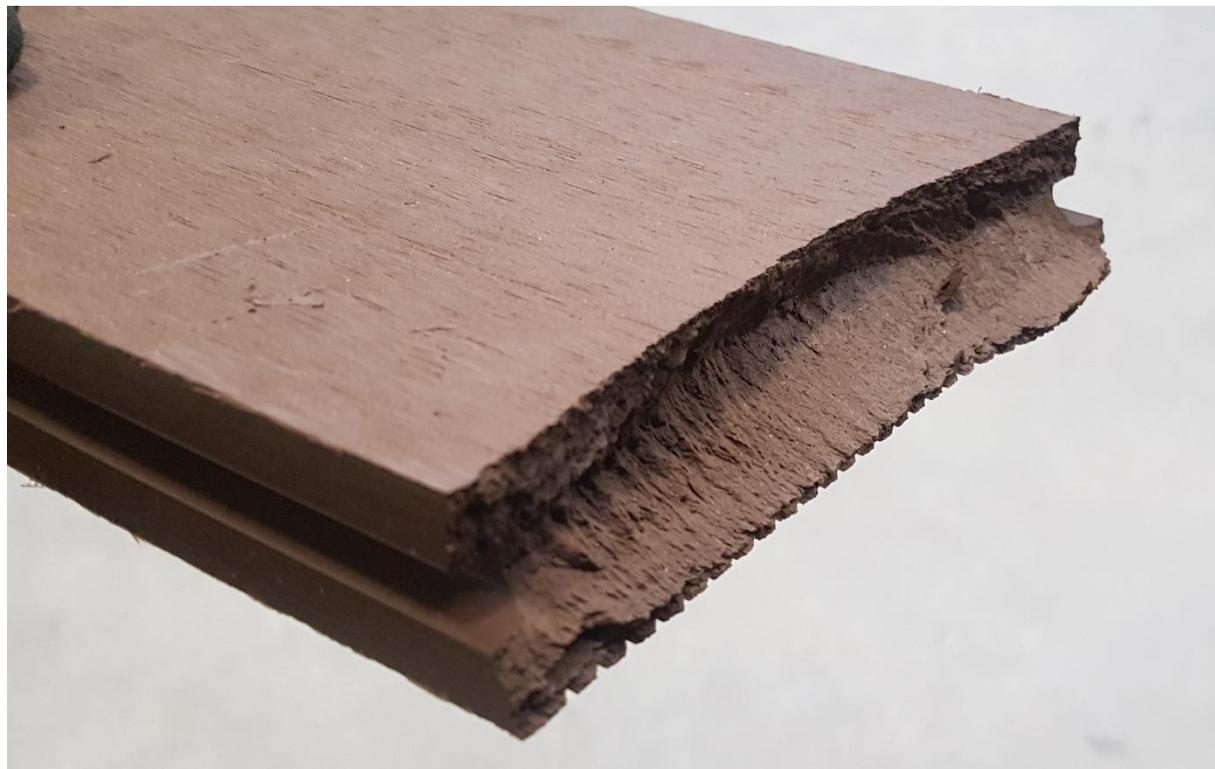
Pictures 9 & 10 – Picture of failed solid decking (both halves).

The average loading a 595mm x 150mm x 25mm with four 27mm x 13mm hollow centres wood-plastic decking can take before reaching its failure limit is 8.06kN with an average deflection of 12.25mm. The average loading a 595mm x 150mm x 25mm solid wood-plastic decking can take before reaching its failure limit is 6.42kN with an average deflection of 7.78mm.

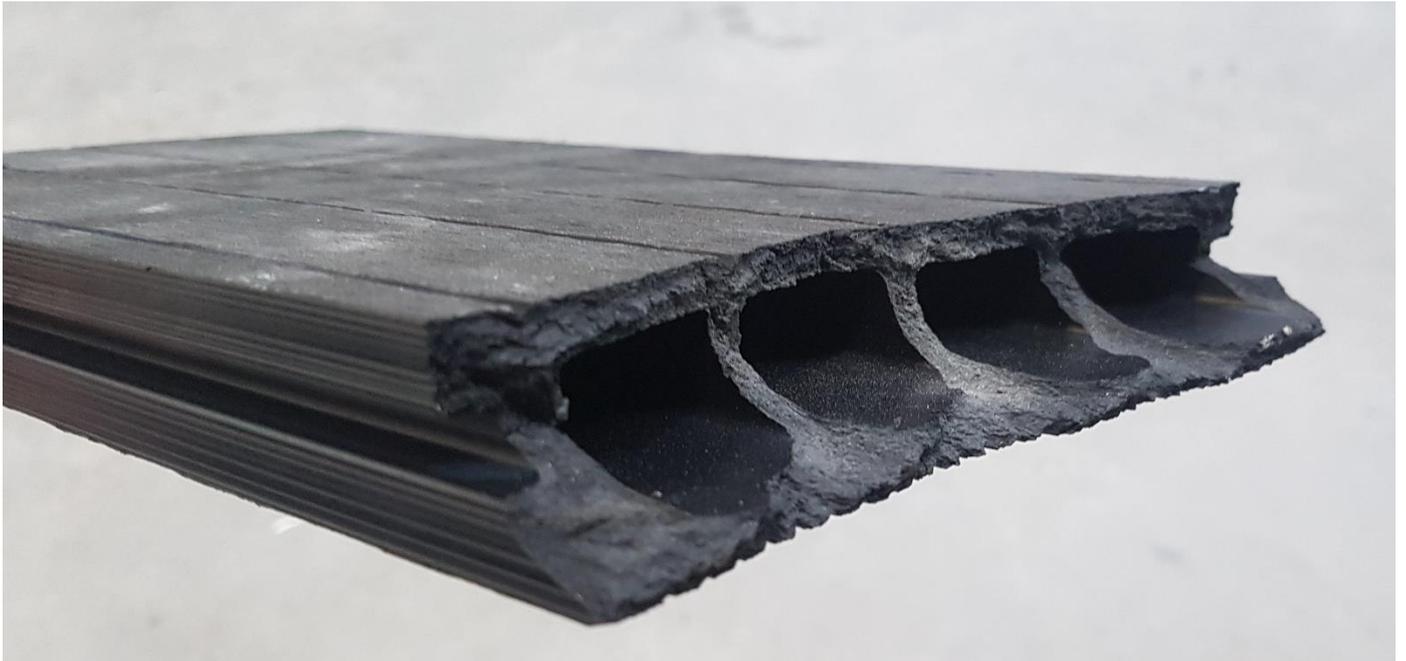
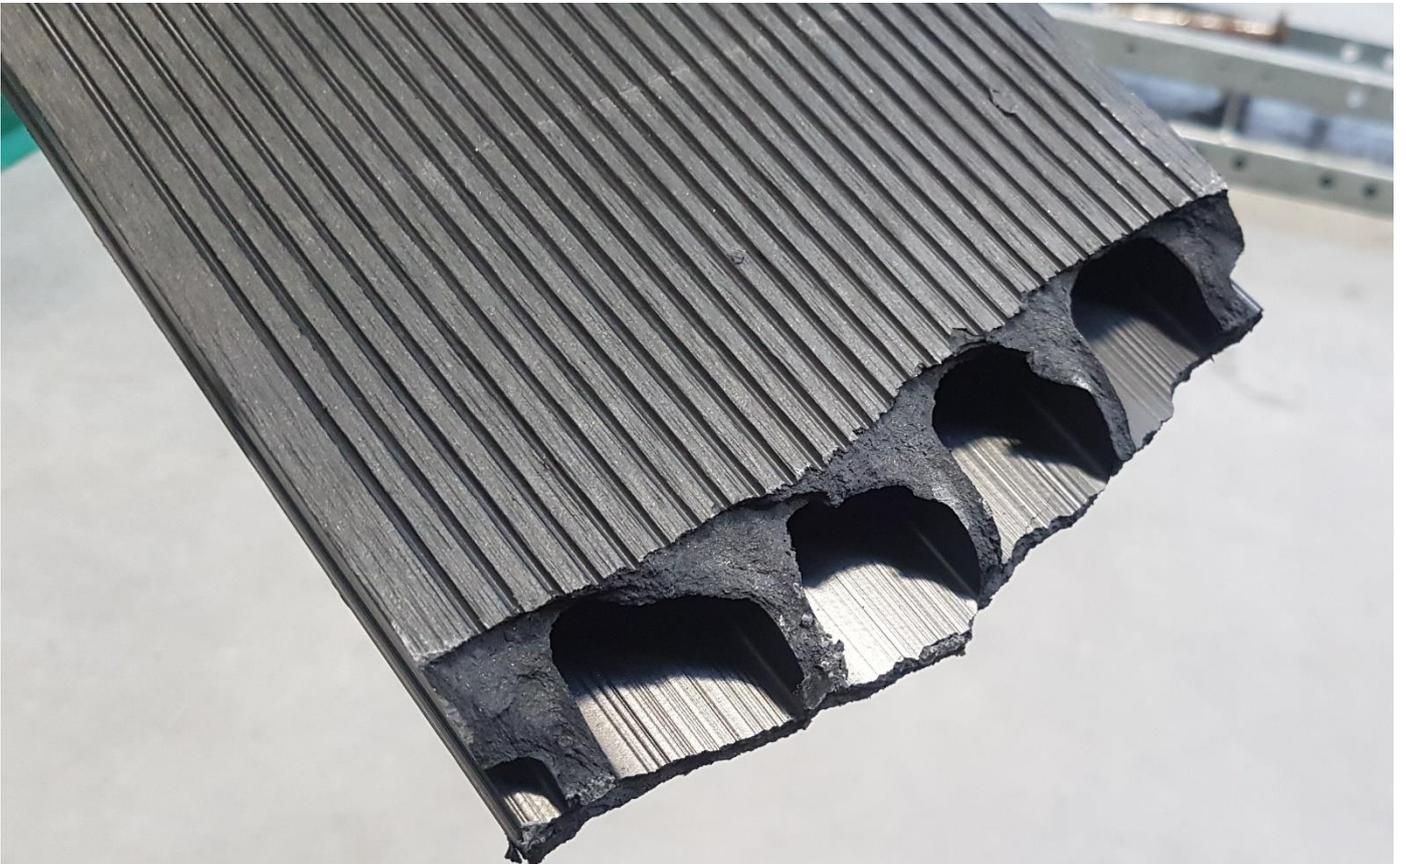
Pictures 11 & 12 – Picture of the failed hollow decking (both halves).
